20-251E

Re: **World Trade Center**
New York, New York

One World Trade Center

World Trade Center
New York, New York

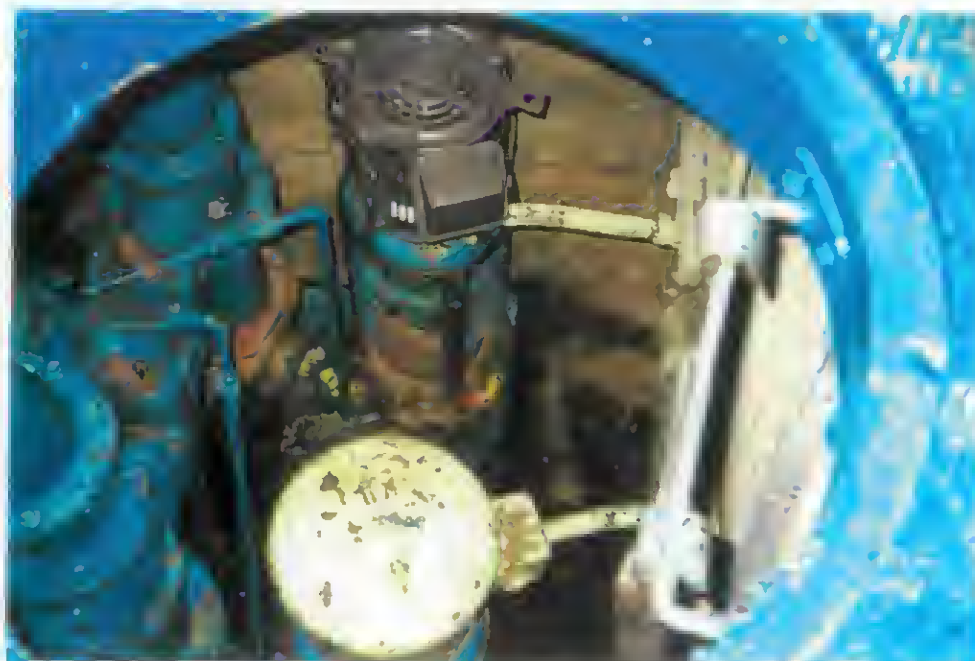
Photograph M10

Pumps within an
ejector pit

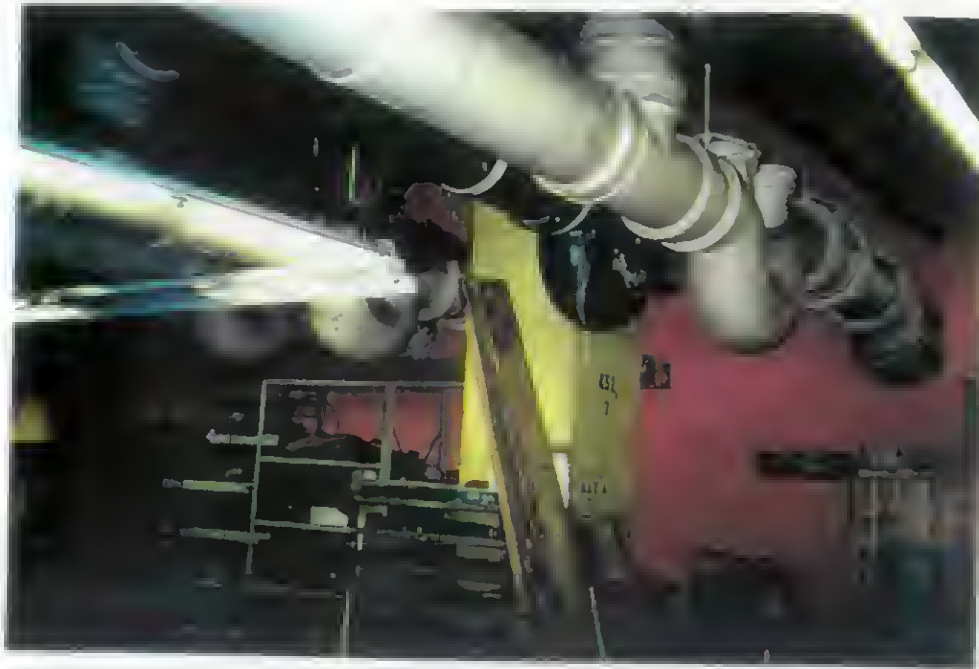
Photograph M11

House traps within
subgrade space

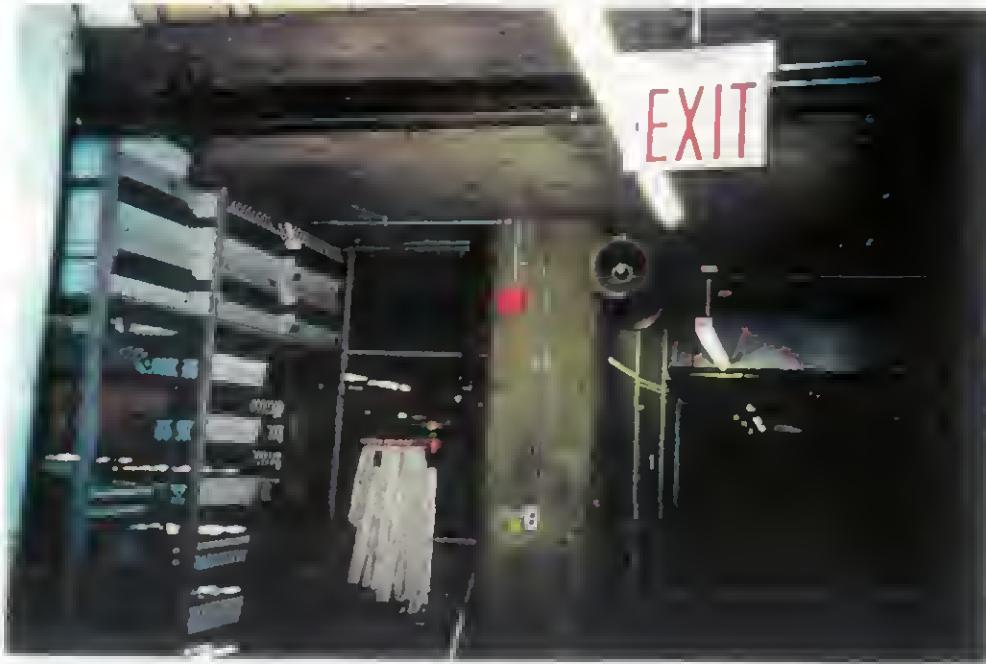
Photograph M13

Life safety devices
within a subgrade
storage area
